COLUMBIA DAM

NJ 00124

**PHASE 1 INSPECTION REPORT
NATIONAL DAM SAFETY PROGRAM**

OVERVIEW
COLUMBIA DAM
13 December 1978

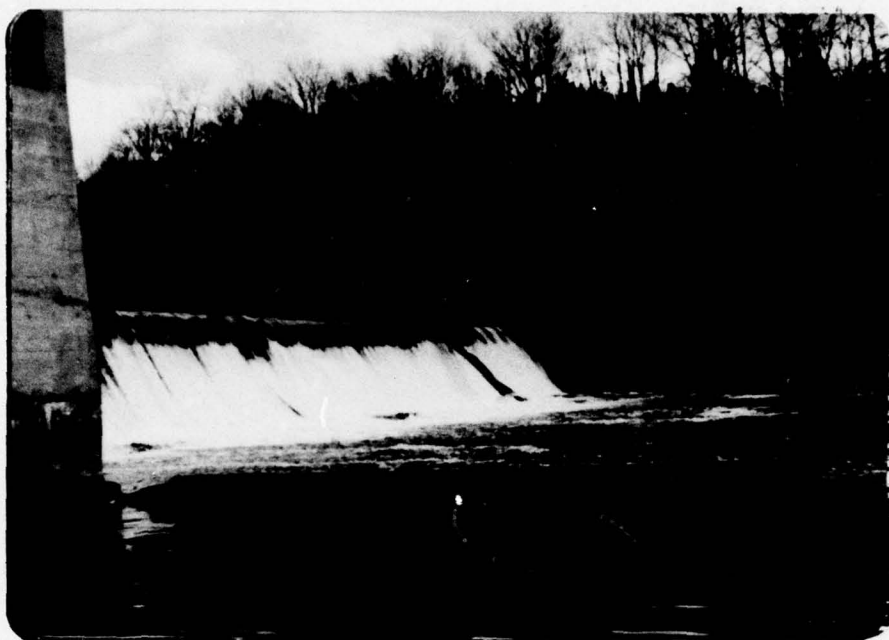
Spillway and entrance to interior of
spillway at right of photo.

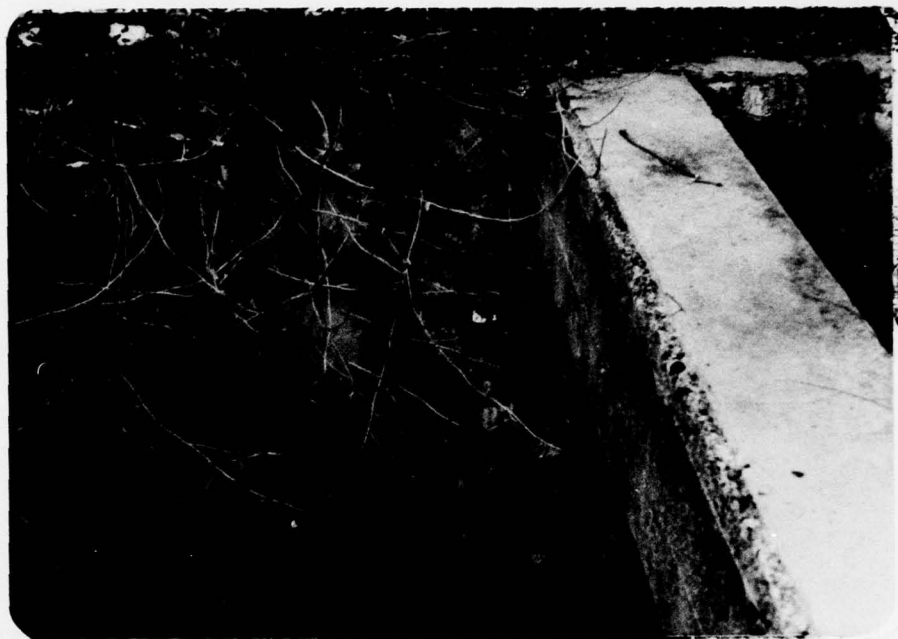
Cracked and deteriorated concrete at
right abutment upstream of Power House.

3. Repair cracks and deterioration of concrete of the power house at the right abutment of the dam and at the entrance and interior of the spillway at the left abutment. This should be done soon.

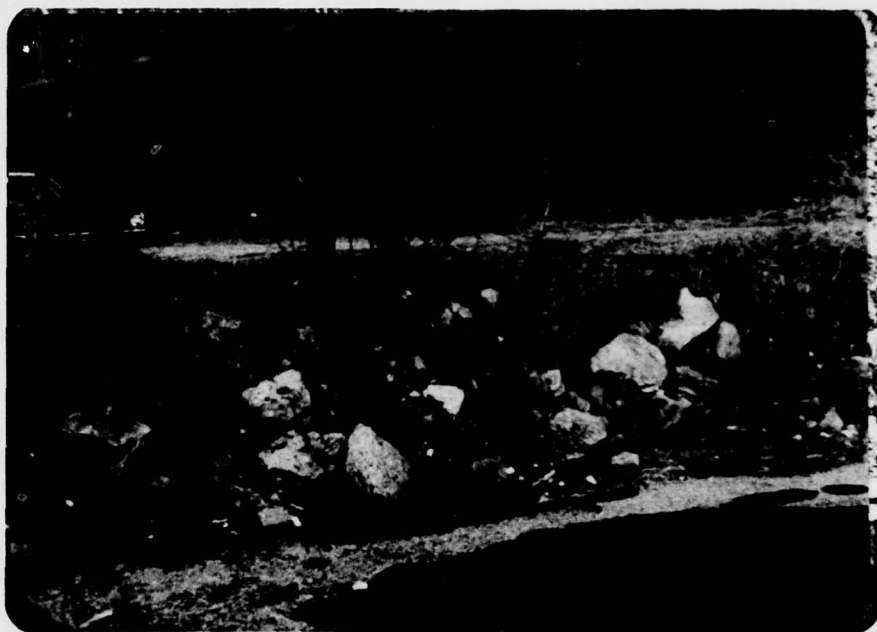
Deteriorated riprap at upstream right abutment.

7. Upstream and downstream riprap should be repaired and areas of the abutments where erosion has occurred should be backfilled and suitably protected against further erosion. This should be done in the near future.

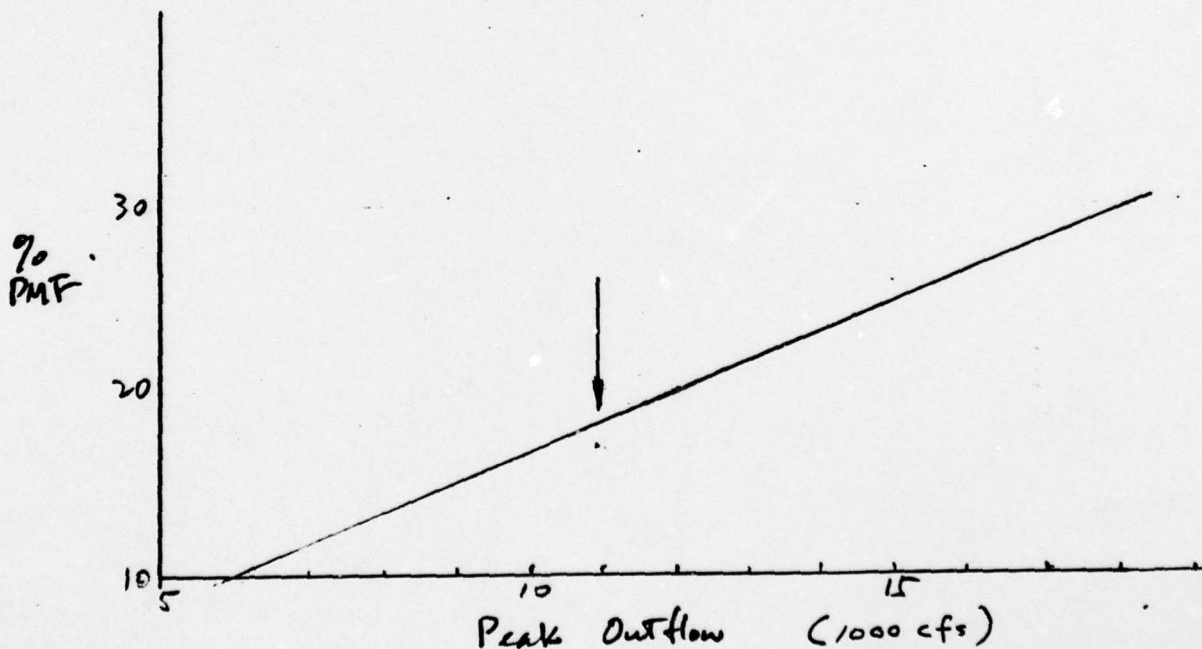
3. Dam overtops at approx. El. 291 with $Q = 10890$ cfs
 \therefore dam can pass approx. 18 % of PMF.
